# Manhole Inspection Summary

Manhole # S39EE\_024MH

Insp Date: **1/14/08 11:11 AM**

**Location** Address: **E 923 CHASE ST**

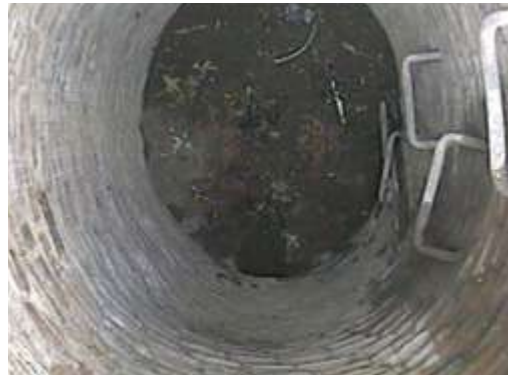
Top View

OUTGOING AT 6'O'CLOCK

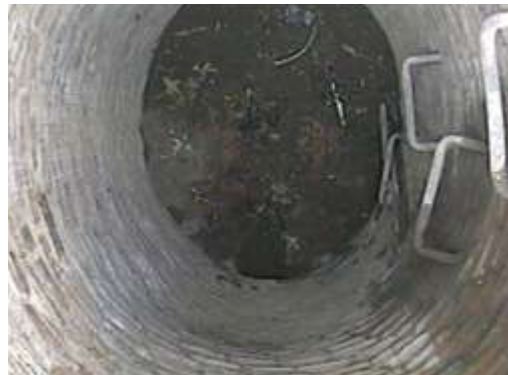
Defect 2

corroded step

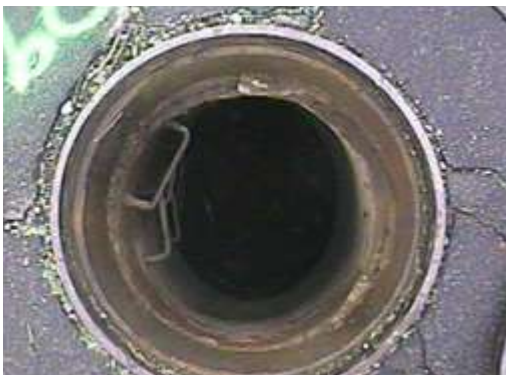
Defect 1

deteriorated frame adjustment

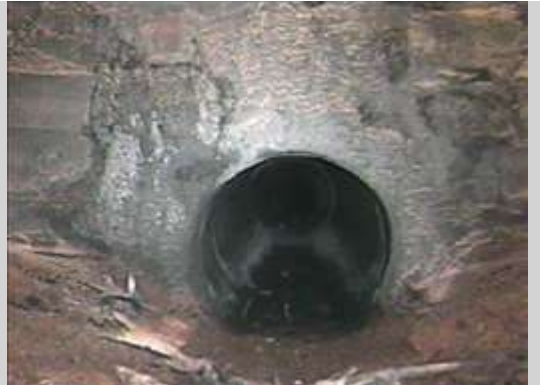
12 O'Clock Outflow

8 in. Circular Gravity Sewer  
Pipe Out @ 12 O'Clock
